# Southeast Power Plant Manganese Deposition Control

## History:

A power plant located in the southeast was experiencing manganese deposition on their stainless steel plate and frame heat exchangers. The deposition eventually caused failure to both heat exchangers shutting the plant down until a replacement could be appropriated.

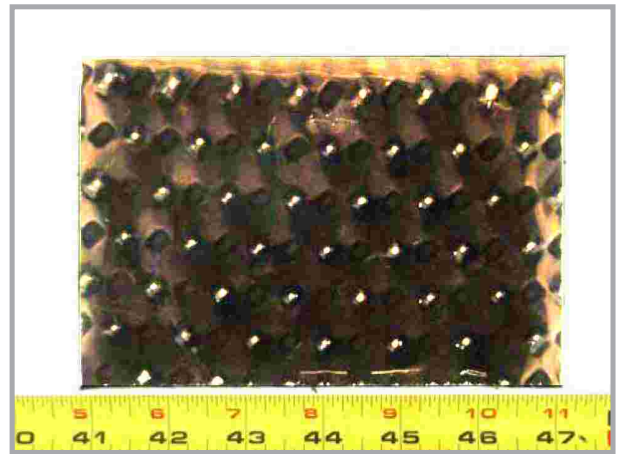
Deposits on the cooling tower side of the plates contain as much as 28% manganese. The relatively high manganese content of the deposits suggests that pitting was most likely promoted by deposition of cathodic manganese containing oxides. Chloride pitting did not appear to be the result of the material defects. Chlorides were not detected within or outside of the pits.

*Heavily Deposited Plate, 0.41X*

An effective chemical program is needed that will prevent manganese deposition from occurring and protect plant assets. ChemTreat's high performance polymer and scale inhibitor package has shown excellent efficacy of inhibiting manganese deposition in other facilities with known manganese deposition. A program was initiated utilizing this technology and three years later, there have been zero failures.

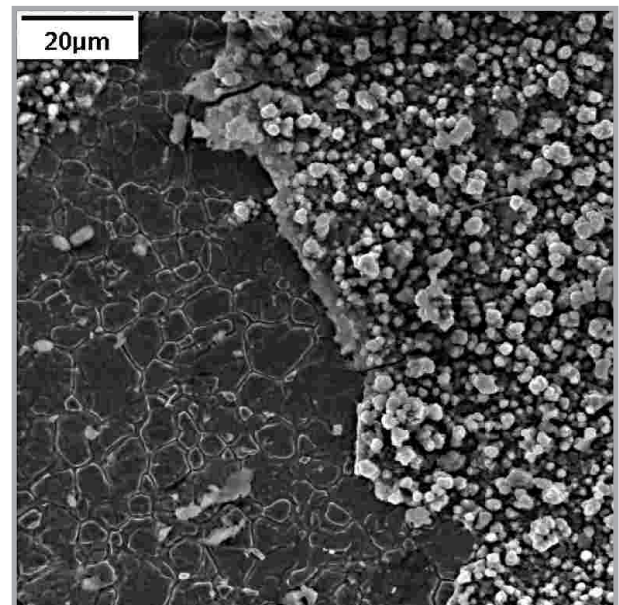
*Heavily Deposited Plate, 830X*

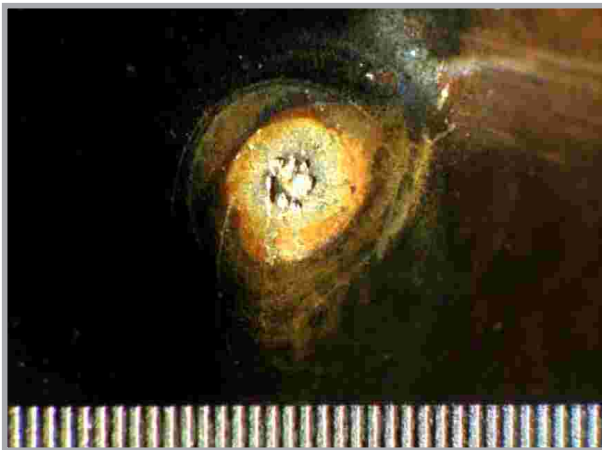
Pitting initiated at the heavily deposited side. No evidence of pit initiation on the closed cooling side of the plate. Pitting exhibited steep walls and undercut cavities. The microstructure consists of infrequent elongated delta ferrite stringers in an equiaxed austenite matrix. Preferential attack of elongated delta ferrite stringers was not apparent. Infrequent patches of deformation bands indicate some work hardening during the plate-forming process. The microstructure is consistent with an annealed and subsequently cold worked austenitic stainless steel.

*Representative Pits, 9.0X*

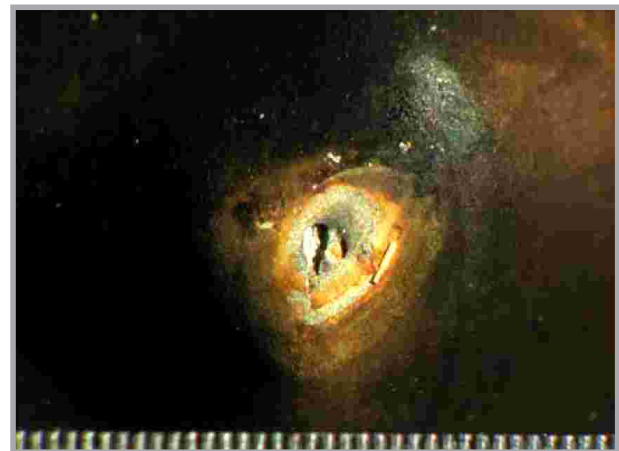
*Representative Pits, 9.0X*

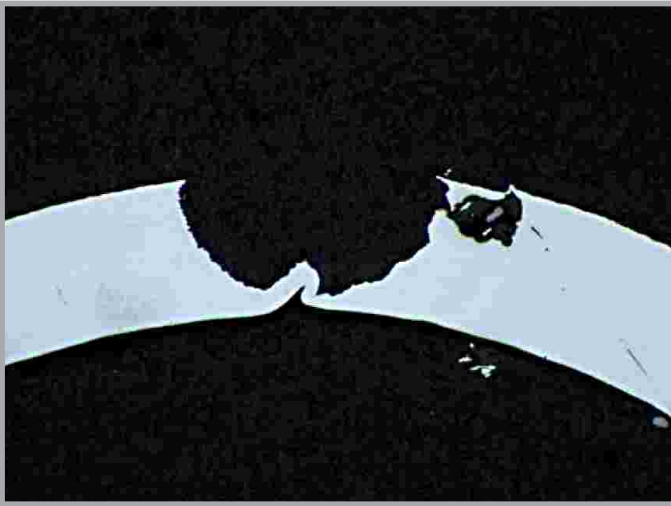
*Representative Pit, 40X*

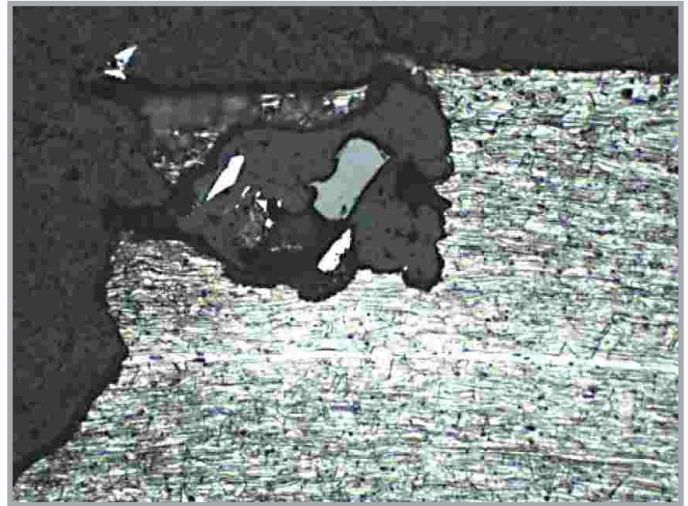
*Undercut Portion of Pit, 80X*

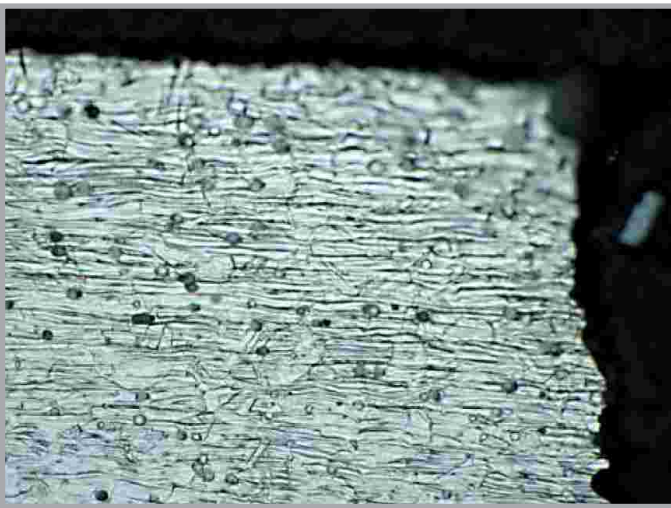
*Edge of Pit, 40X*

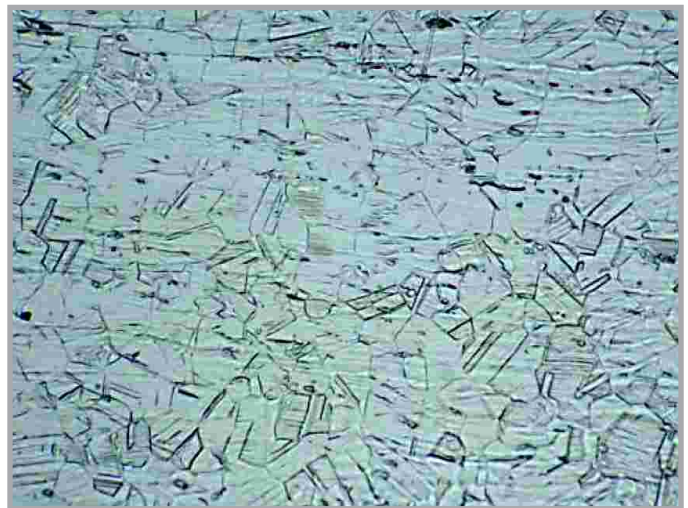
*Mid-Wall Microstructure, 320X*

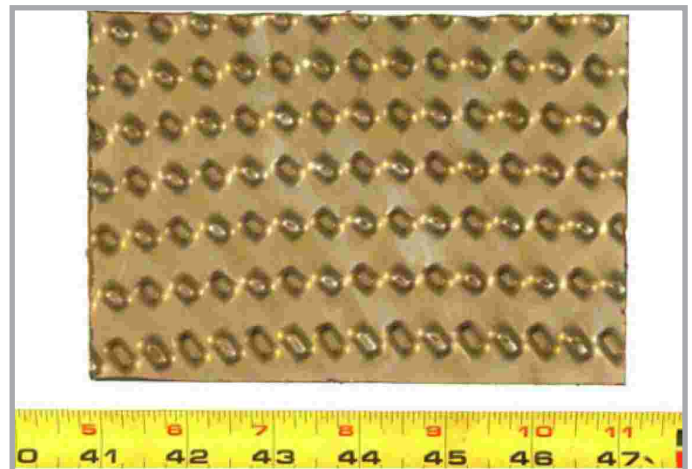
*Plate Cleaned With ChemTreat Program*
