Southeast Power Plant Manganese Deposition Control

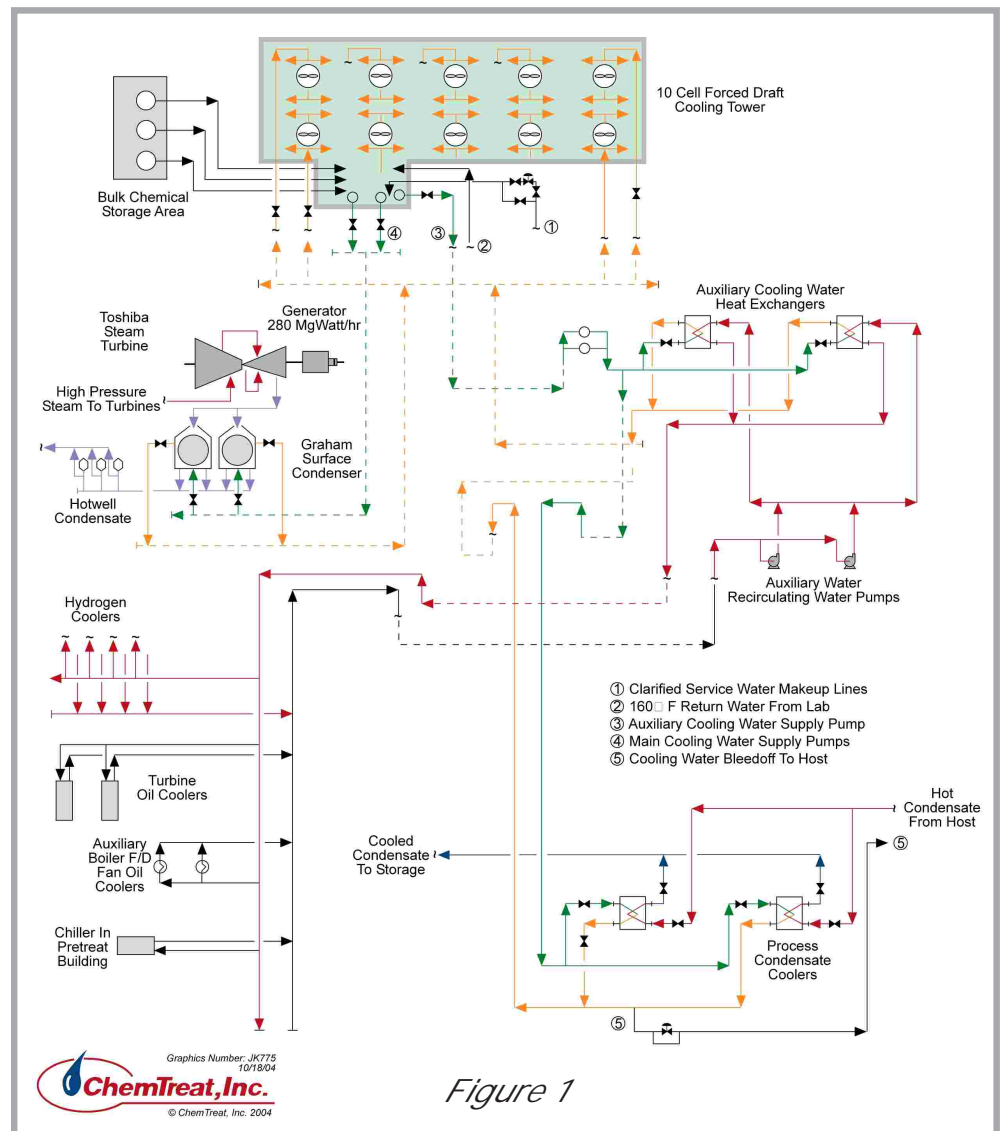
Figure 1 shows the general layout of the cooling system at the power plant. The auxiliary cooling heat exchangers developed leaks because of stainless steel plate pitting.

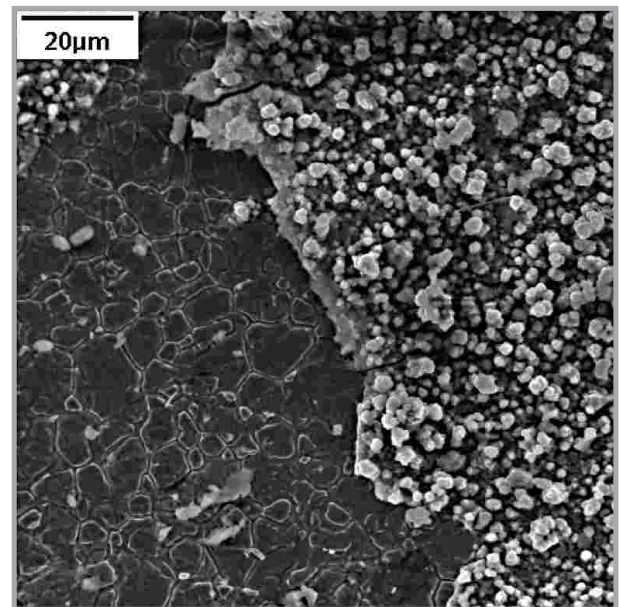
Heavily Deposited Plate, 830X

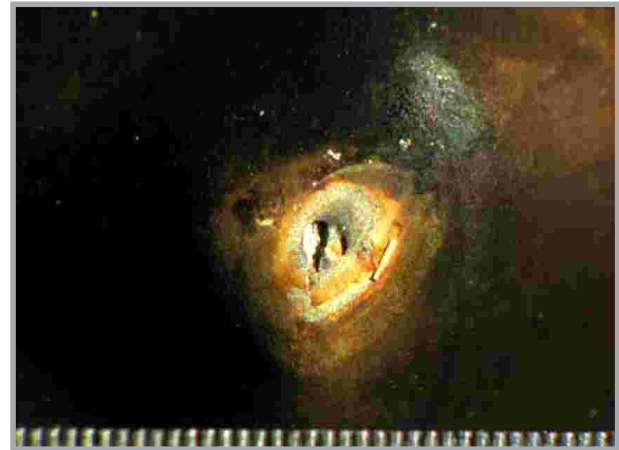
Representative Pits, 9.0X

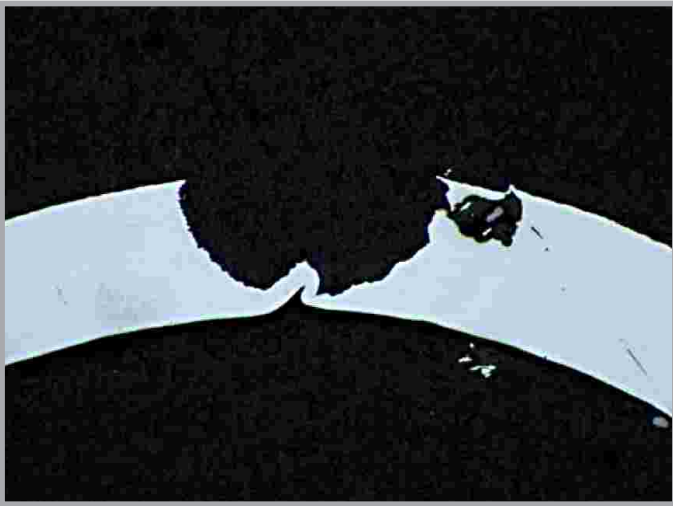
Representative Pit, 40X

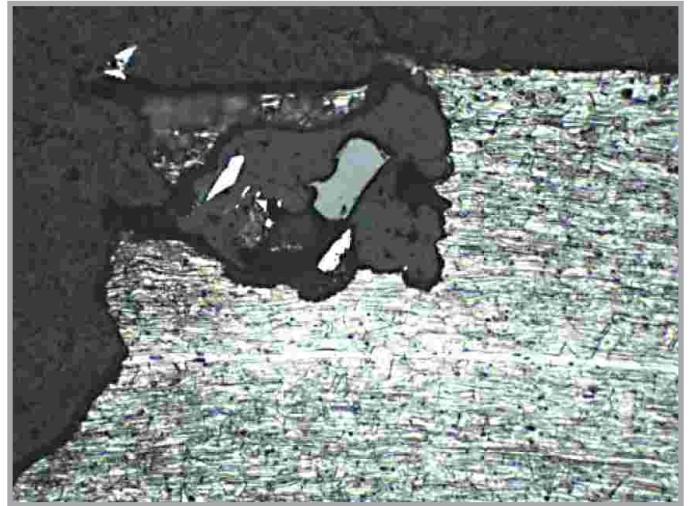
Undercut Portion of Pit, 80X

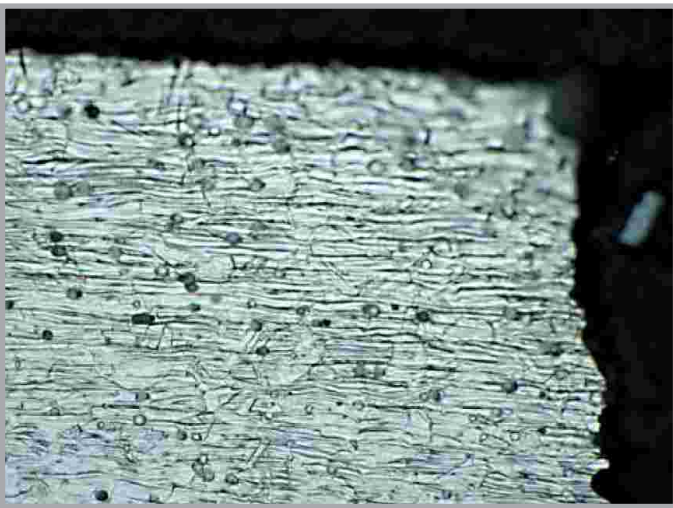
Edge of Pit, 40X

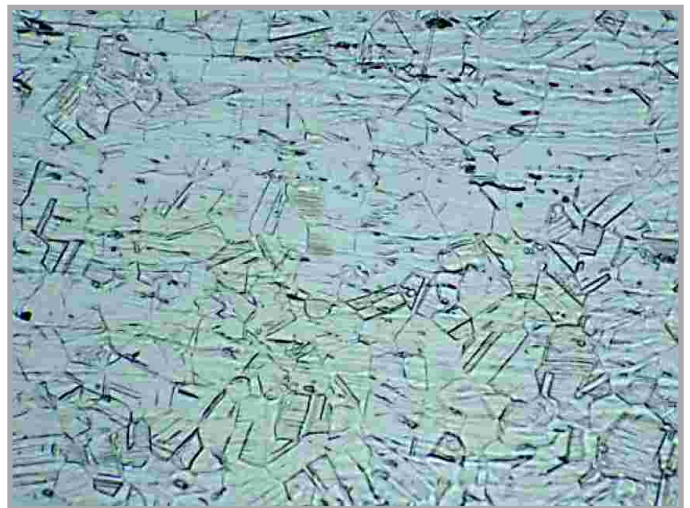
Mid-Wall Microstructure, 320X

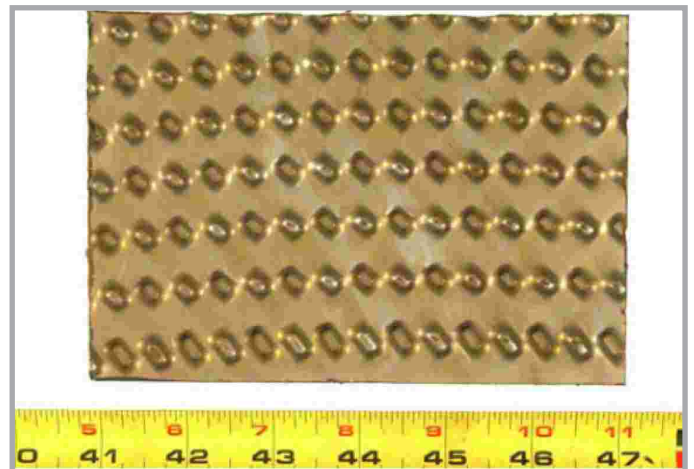
Plate Cleaned With ChemTreat Program

An effective chemical program is needed that will prevent manganese deposition from occurring and protect plant assets. ChemTreat's high performance polymer and scale inhibitor package has shown excellent efficacy of inhibiting manganese deposition in other facilities with known manganese deposition. A program was initiated utilizing this technology and three years later, there have been zero failures.
