FlexPro® Arrests Corrosion and Restores Productivity at Northeast Biomass Power Producer

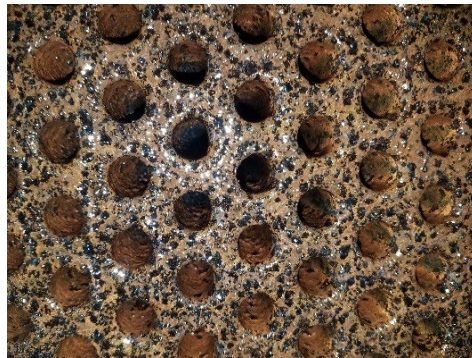
A Northeast Biomass Power Producer struggled to meet their power production targets because of severe condenser steel corrosion caused by improper lay-up and lack of start-up passivation. The steel condenser ends were left covered in a humid environment for approximately 12 months prior to installation, and the previous water treatment supplier failed to advocate for cleaning and passivation prior to operation. When placed into service, the condenser's 3/8-inch rifled ferrous tubes fouled with corrosion products quickly, limiting plant cooling and power plant production.

Figure 1: Photo of tube sheet after cleaning and before treatment optimization. The photo shows the extent of the previous damage and signs of additional corrosion resulting from inadequate anodic protection.

ChemTreat successfully cleaned the system using a combination of chemicals (CT38 and CN5600) and a mechanical cleaning. The system makeup water contained 189 ppm of chlorides, 173 ppm of calcium, and regularly cycled above 700 ppm chlorides. The power plant also discharged directly to a stream, so phosphorous and zinc were not allowed in the discharge. ChemTreat now successfully treats the system using FlexPro® technologies.

The system was cleaned with a combination of neutral pH cleaner CT38 and FlexPro® CN5600. The treatment program was further improved through regular monitoring of the system flow, heat exchanger performance, corrosion coupon rates, and iron. ChemTreat optimized the alkalinity control point and fed supplemental corrosion inhibitors (FlexPro® CL5737 as a supplemental anodic inhibitor with FlexPro® CL5688 and separate halogen stable azole feed using ChemTreat CL4132) until the demand was satisfied.

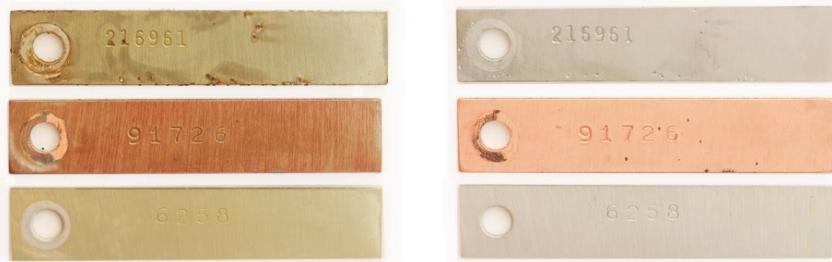
The system now maintains consistent flow through the condenser, and power production is maintained near design levels. The latest corrosion rates dropped dramatically to 0.4 mpy for mild steel, less than 0.1 mpy for 304 stainless steel, and less than 0.1 mpy for copper. These are excellent results considering over 700 ppm chlorides are present in the cycled water.

Figure 2: Recent coupons before and after cleaning. The mild steel corrosion rate is 0.4 mpy after optimization.

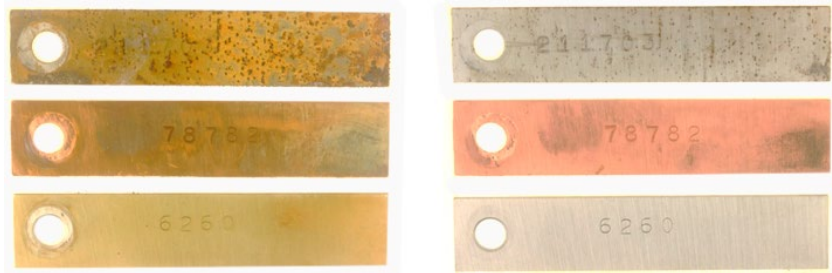
Figure 3: Coupons before program optimization showing pitting from inadequate anodic protection. The mild steel corrosion rate is 5.4 mpy.

A minimum 120 ppm 'M' alkalinity was required to achieve the desired coupon results, and higher levels dramatically reduced corrosion. The optimum dose for economic performance was supplemental corrosion inhibitor shot fed on a periodic basis.

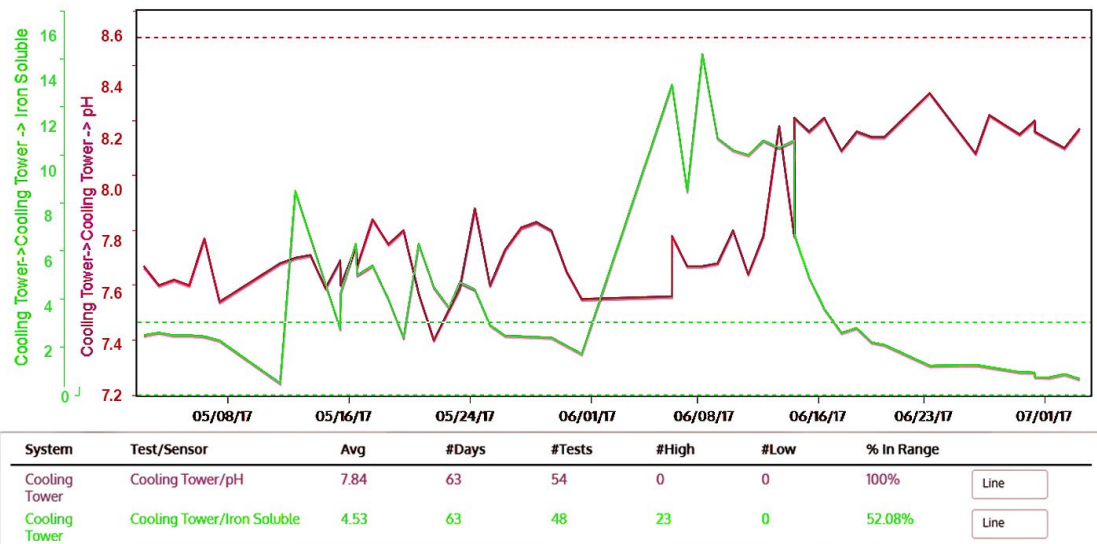
Figure 4: CTVista®+ graph plotting iron against the pH. Note the dramatic drop in iron levels once the 'M' alkalinity threshold is maintained.
