# Filmic Corrosion Inhibitor: Latin America Refinery FCC Unit

A refinery located in Latin America has an FCC unit with a capacity of 15,000 bbl/day. This unit has an H<sub>2</sub>S stripping tower to stabilize the FCC naphtha. Every three months, the failure of the FCC naphtha reboiler in the naphtha side housing rich in H<sub>2</sub>S caused unplanned plant stops. ChemTreat and the refinery established a work plan to determine the corrosion mechanism and correct the issue.

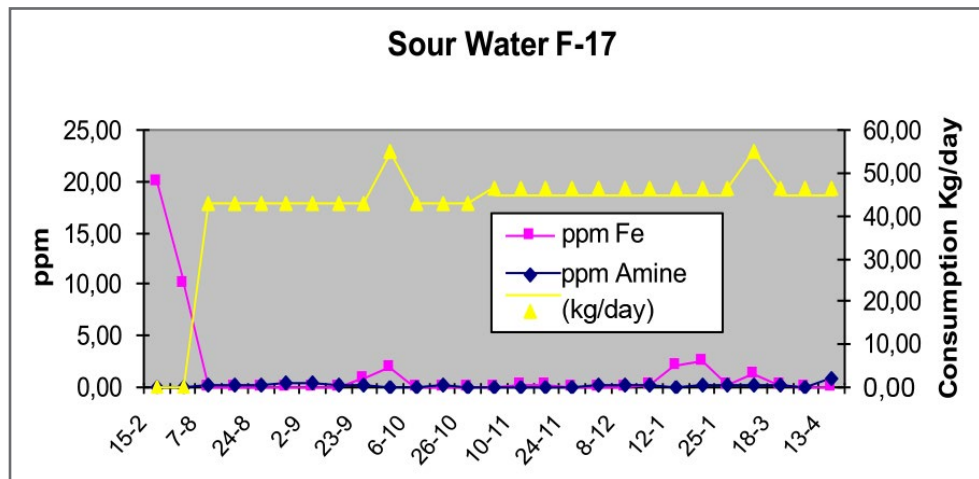
Figure 3: Treatment Results

Figure 3 illustrates that as soon as the Lipesa 229 injection was started, iron ppm fell on the F-17 drum (sour water) from more than 20 ppm to less than 1 ppm at a consumption of only 45 kg/day. The Lipesa 229 has been injected without interruption, and the blistering failure has not been repeated.
