## CASE STUDY

# Improved Reliability and Profitability at a Gulf Coast Chemical Plant with FlexPro® Technology

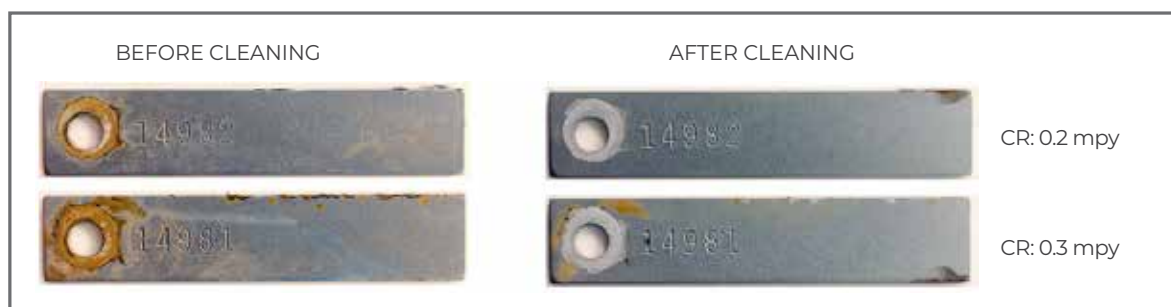
### Corrosion coupon results for mild steel coupons placed at the heat exchanger exit

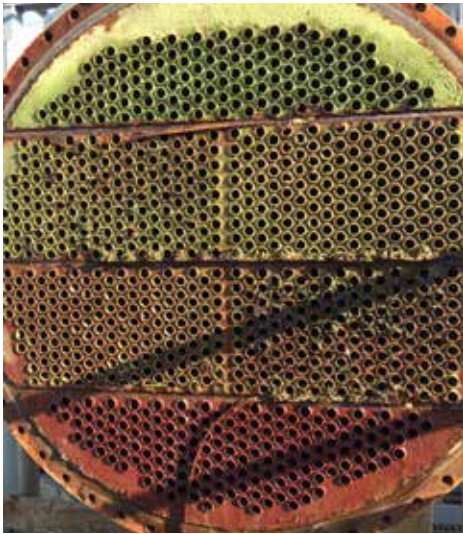
2015: Competitive PO<sub>4</sub> Technology

These pictures illustrate how the competitive PO<sub>4</sub>-based treatment resulted in severe calcium phosphate deposition and possible biofouling as well. ChemTreat's FlexPro® technology has resulted in heat exchangers free of corrosion and scaling.

The following images show the comparison of heat exchangers when treated with a competitive, PO<sub>4</sub>-based technology during the 2015 turnaround and ChemTreat FlexPro® technology during the 2018 turnaround cycle.
