TITAN360® Provides Superior Corrosion Protection

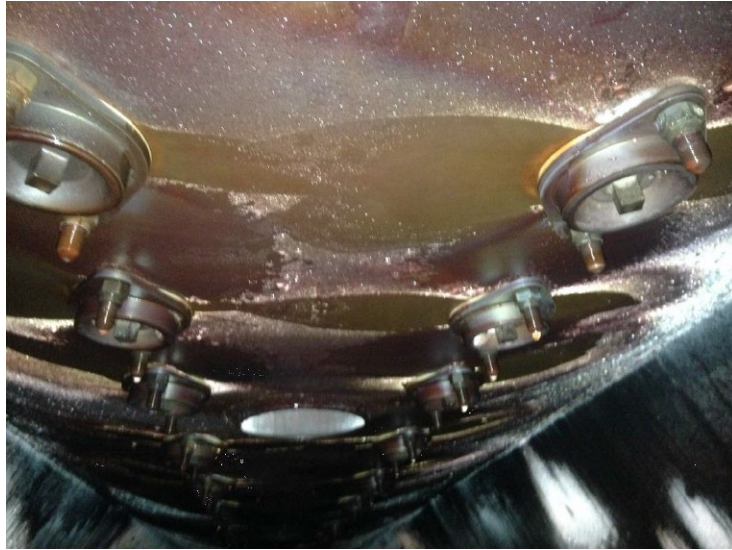
Figure 1: Deaerator dome and spray nozzles with water droplet accumulation

A boiler inspection revealed that TITAN360[®] formed a protective film in the early sections of the cycle. The most prominent filming was prevalent up through the deaerator. This was evident by the non-wetted metal surfaces and presence of beaded water droplets, which can be seen in Figures 1 and 2. The deaerators had an excellent surface oxide passivation for all visible areas and there was no sign of any active corrosion or flow accelerated corrosion on any surface or internal component.

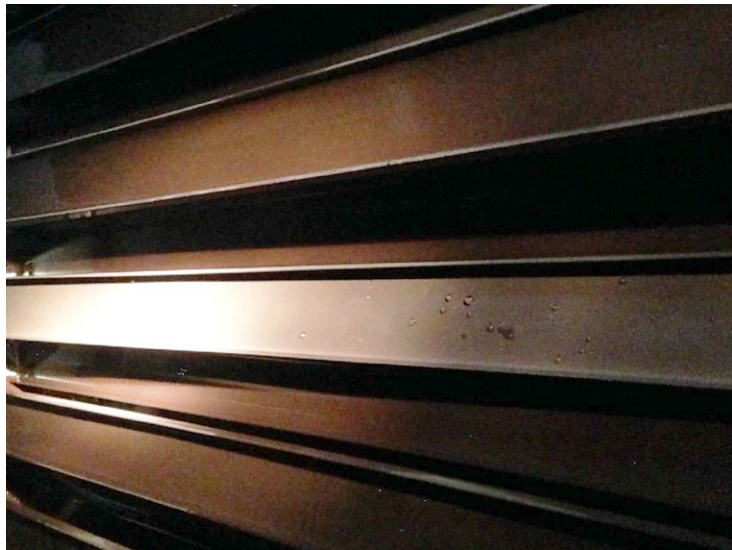
Figure 2: Deaerator trays with non-wetted surface and beaded water droplets.
