CASE STUDY

TITAN360™ Provides Superior Corrosion Protection

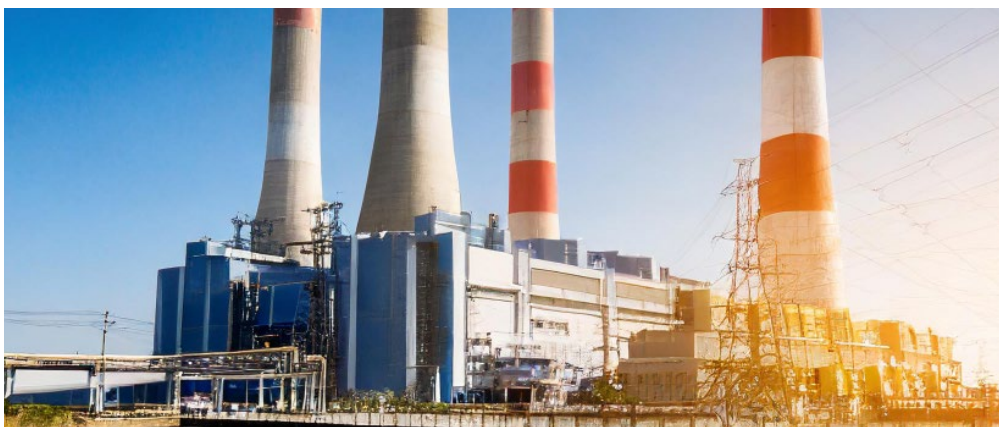
Within a few weeks, TITAN360 began to dramatically decrease iron levels and easily stabilize the pH of the system to 9.0- 9.6 without additional intervention. Additionally, with the simple test kit, the operators were able to consistently maintain and measure a residual. This was a considerable improvement over the previous treatment, which lacked the means of monitoring the proper dosage. The presence of residual or “free” filming amine with TITAN360 indicated there was sufficient protection of the metal surface. efficiency of the boiler, with a blowdown reduction of 75%.

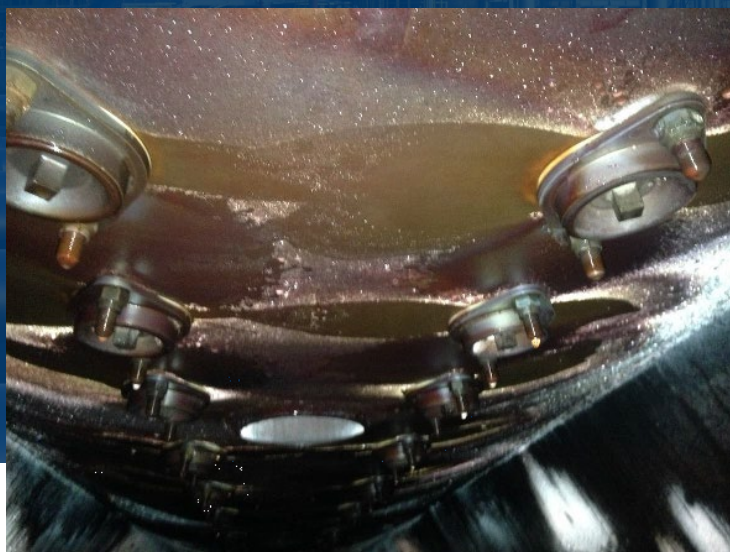
Figure 1: Deaerator dome and spray nozzles with water droplet accumulation.

A boiler inspection revealed that TITAN360 formed a protective film in the early sections of the cycle. The most prominent filming was prevalent up through the deaerator. This was evident by the non-wetted metal surfaces and presence of beaded water droplets, which can be seen in Figures 1 and 2. The deaerators had an excellent surface oxide passivation for all visible areas and there was no sign of any active corrosion or flow accelerated corrosion on any surface or internal component.
