# ChemTreat CL450 Easily Removes Oil and Grease Fouling

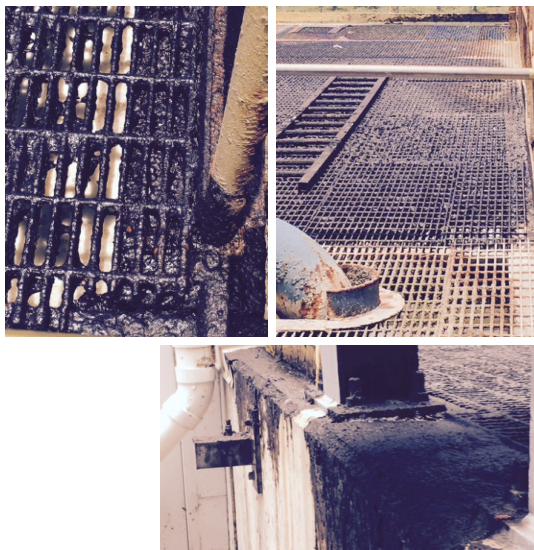
**BEFORE CL450 TREATMENT**

A cooling tower at a 60MW power plant in the Southeastern United States was heavily contaminated with an oil-based lubricant. A heavy foam quickly developed, covering the cooling tower deck grates with a greasy, tar-like substance. Defoamer knocked down the foam, but the fouling above the waterline dried to a black tar-like substance that was difficult to remove. The customer attempted to remove the fouling with a power washer, but it was ineffective.

The following photos show the greasy tar prior to the application of CL450. Side effects of the treatment produced additional benefits. There was a significant improvement in cooling water microbiological performance immediately after the cleaning that could be attributed to the surfactant's biodispersant properties. The customer was very happy with the ease of removing tenacious deposits after applying CL450.

ChemTreat used a surfactant to attempt a more successful cleaning. CL450 was foamed onto the greasy deposits using a 50 percent solution made in tap water. The product soaked in for 10–20 minutes. When the customer used the power washer to clean the grates after applying CL450, the fouling was easily removed.
