Southeast Power Plant Manganese Deposition Control

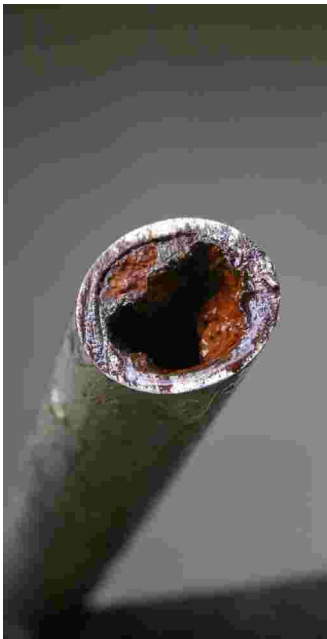
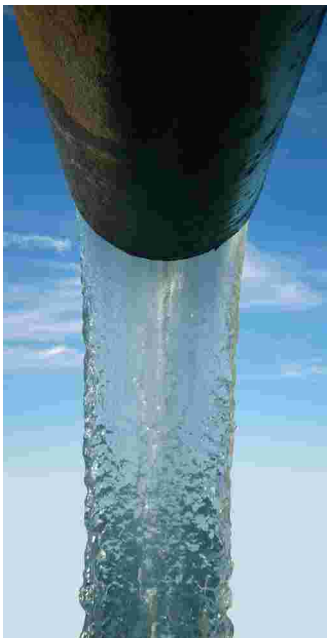
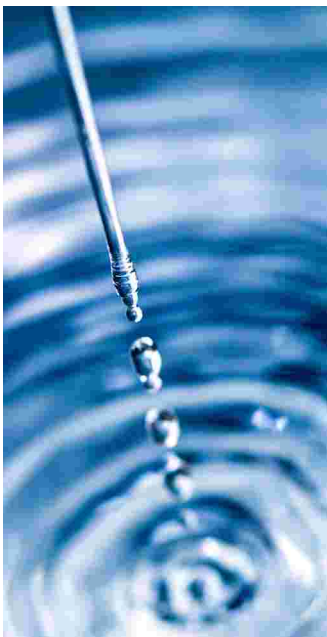
Figure 1 shows the general layout of the cooling system at the power plant. The auxiliary cooling heat exchangers developed leaks because of stainless steel plate pitting.
