# Filmic Corrosion Inhibitor: Latin America Refinery FCC Unit

A refinery located in Latin America has an FCC unit with a capacity of 15,000 bbl/day. This unit has an H<sub>2</sub>S stripping tower to stabilize the FCC naphtha. Every three months, the failure of the FCC naphtha reboiler in the naphtha side housing rich in H<sub>2</sub>S caused unplanned plant stops. ChemTreat and the refinery established a work plan to determine the corrosion mechanism and correct the issue.

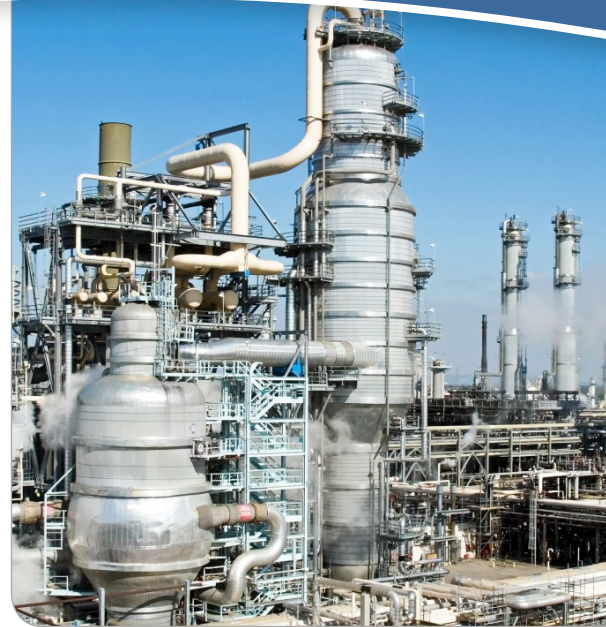
Figure 1: Photo of the Issue

As shown in Figure 2, the presence of water, carbon steel, and H<sub>2</sub>S produce ferric sulfide. In the presence of HCN (a gas that forms in FCC), ferric sulfide reacts to form atomic hydrogen. When it bonds with another hydrogen atom, there is a sudden strong increase in localized pressure as a result of the molecular hydrogen formation. This sudden pressure increase inside metal produces the blistering shown in Figure 1.

ChemTreat's recommendation was based on cutting the formation mechanism of the atomic hydrogen through the application of a film amine capable of forming a protective film on the carbon steel. The recommended product was Lipesa 229, and the point of injection was the feeding of destabilized naphtha to the stripping tower.
