CASE STUDY

Manufacturing Facility Saves on Chemical Costs and Water Usage with Demineralizer Improvements

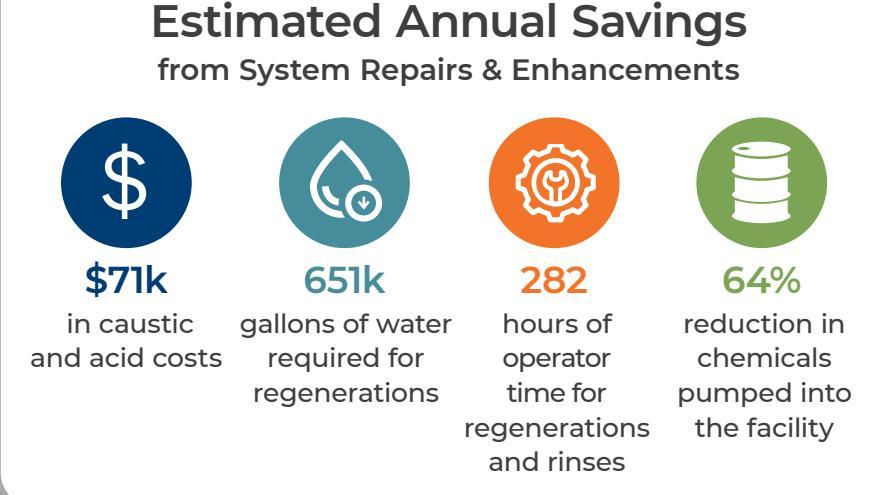
These improvements dramatically improved the function of the mixed bed demineralizers.

- Purchased new resin.
- Performed extensive repairs on the vessels to reduce resin loss.
- Added resin to the beds and regenerated the resin manually.
- Correctly programmed the water flow automation process.
