# Medical Instrument Sterilization

## Background

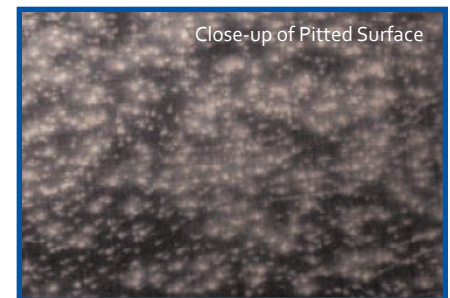
Instruments primarily affected were the larger knives as shown in Fig.1. This corroded amputation knife after removal from the automated washing process prior to sterilization. Examination showed rust-colored corrosion stains on the blade surface. The handle showed no evidence of staining or corrosion.

Since the knife blade was corroding and not the handle, it was determined the chromium content of the blade was marginal for the corrosion resistant service required. In addition to pitting corrosion, the surface was found to have clusters of mineral deposits. The first three of four automated washing stages used un-softened tap water and the final rinse stage used demineralized water but only rinsed for ten seconds.

Changes in the wash cycle stages were instituted, purified water was incorporated earlier in the washing procedure, and additional care was specified to ensure proper rinsing. Additional rigorous attention was paid to the pre-wash steps and renewed vigilance regarding water source quality. In addition, a more corrosion-resistant blade alloy was recommended. The facility has been corrosion free and saw overall improvement in the instrument sterilization process.
