# ChemTreat Solves Can Quality Problems For Major Brewery

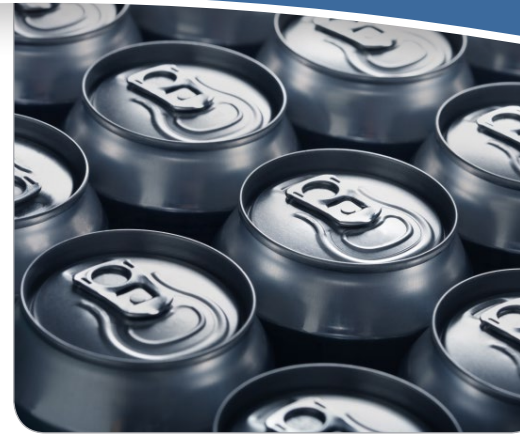
A large Midwestern brewery was experiencing classic can dome staining in two of its can lines, which had become an increasing issue due to the implementation of water conservation measures that introduced inconsistencies in water quality. These inconsistencies caused increased retention times in the pasteurizer and difficulties keeping contaminants out of the pasteurizer. In addition, a blue-green sticky mass appeared on the suction box screens and internal walls of the pasteurizer.

ChemTreat's R&D lab studied a sample of the blue-green mass with FTIR analysis and found that the major components were conveyor lube, can necker lube, and can overcoat varnish. In addition, two components of the corrosion inhibitor were precipitating in the pasteurizer water. Further testing showed that the blue-green mass was consuming the polymer. ChemTreat recommended countermeasures to reduce organic matter buildup in the heat and hold zones. The pasteurizers were taken offline and fully cleaned with pressure washers to remove all of the organic deposit. In addition, ChemTreat provided a reformulated, custom product suitable for the more severe conditions of the pasteurizer.

After the pasteurizers were cleaned and ChemTreat's newly reformulated product was applied, the can staining disappeared and no further problems were seen. Even after six months, the can staining issue has not resurfaced.
