Flocculant Program Improves Recovery and Product Quality at a Copper Mine

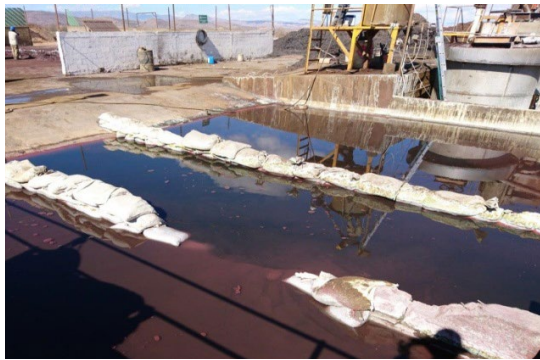
BEFORE: High turbidity in the settling ponds

As seen in the accompanying photographs, these changes provided superior performance, as evidenced by the clarity of the overflow, with turbidity levels dropping to 30–50 Ntus. These results showed that more copper was settling in the sedimentation cone, instead of leaving the process. The mine estimated improved copper recovery by 7 percent.

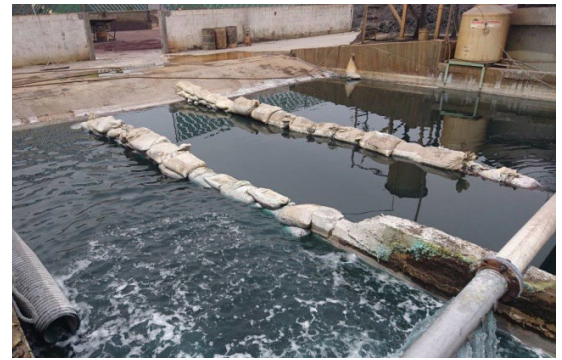
AFTER: Low turbidity in the settling ponds

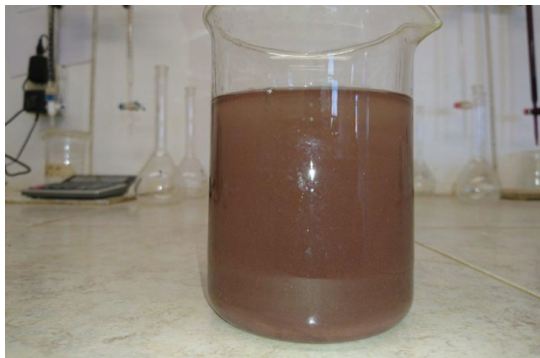
BEFORE: High turbidity in the overflow of the settling ponds

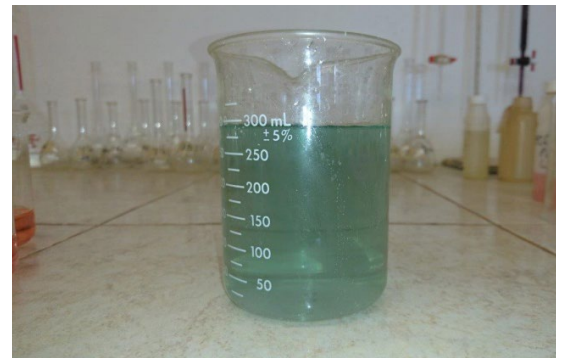
AFTER: Low turbidity in the overflow of the settling ponds
