ChemTreat Improves Operation of Oil Refinery's Flare Gas Recovery Unit (FGRU)

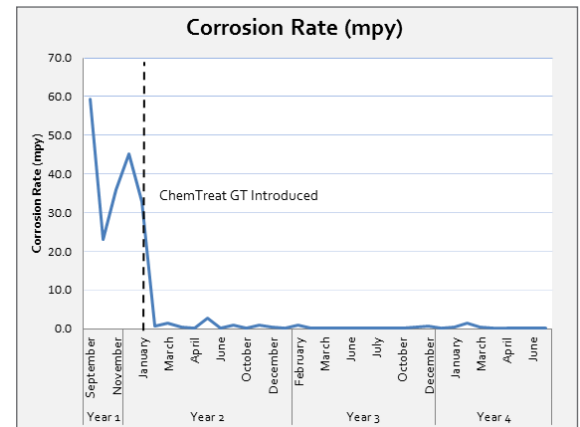
Figure 1: Corrosion data before and after the introduction of ChemTreat GT

After the introduction of ChemTreat GT, FGRU corrosion decreased drastically to an average of 0.45 mpy, as demonstrated in Figure 1. Additionally, water clarity in the sour water blowdown significantly improved, reducing the risk of deposition onto the FGRU. Since ChemTreat GT reduced corrosion and deposition, the FGRU has continuously operated exceptionally well.
