Iron Cleanup at New York-Based Beverage Company

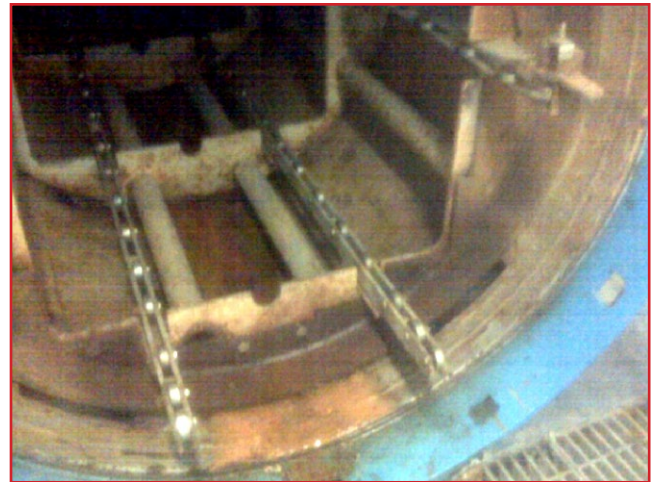
BEFORE

A New York beverage plant constructed to produce milk-based coffee products was preparing for production. With seven million dollars in orders for their product, they had six reconditioned Stock (Rotomat) cookers containing a significant amount of iron deposition. During trial production runs many of the bottles had noticeable iron smudges on the white lids. Production could not proceed because of the inferior-looking product packaging and potential damage to brand value.

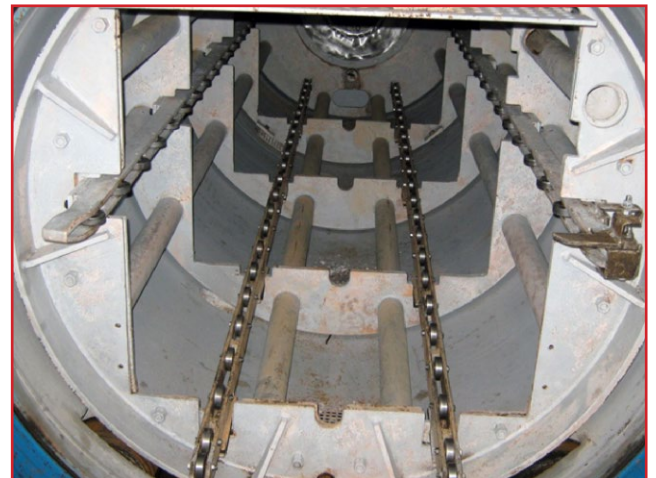
AFTER

Upon inspection, these vessels looked even better than the first cooker as evidenced by a black-gray passivated metal surface. No deposit was visible throughout the cookers. Plant personnel were grateful and the results were “much better than expected.” Subsequently, the plant was started up and the product appearance was superb.

A 7 percent solution of CT38 was utilized in the cooker with the temperature maintained

at 130°–135°F. Throughout the five-hour procedure, circulation from the bottom drum to the top drum was effected. After five hours, the vessel was opened and the results were superb. The plant manager and production manager were ecstatic. Throughout the procedure, the ORP was held negative at -40 mV and the pH stabilized around 6.5.
