Iron Cleanup At A New York-Based Beverage Company

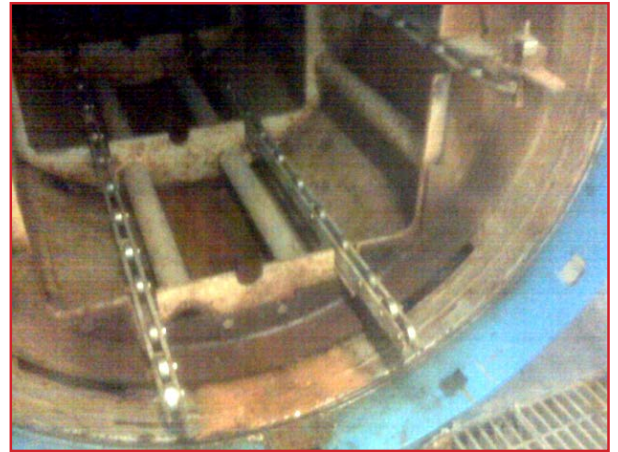
BEFORE

A New York beverage plant constructed to produce milk-based coffee products was preparing for production. With seven million dollars in orders for their product, they had six reconditioned Stork (Rotomat) cookers containing a significant amount of iron deposition. During trial production runs many of the bottles had noticeable iron smudges on the white lids. Production could not proceed because of the inferior-looking product packaging and potential damage to brand value.

A 7 percent solution of CT38 was utilized in the cooker with the temperature maintained at 130°–135°F. Throughout the five-hour procedure, circulation from the bottom drum to the top drum was effected. After five hours, the vessel was opened and the results were superb. The plant manager and production manager were ecstatic. Throughout the procedure, the ORP was held negative at -40 mV and the pH stabilized around 6.5.

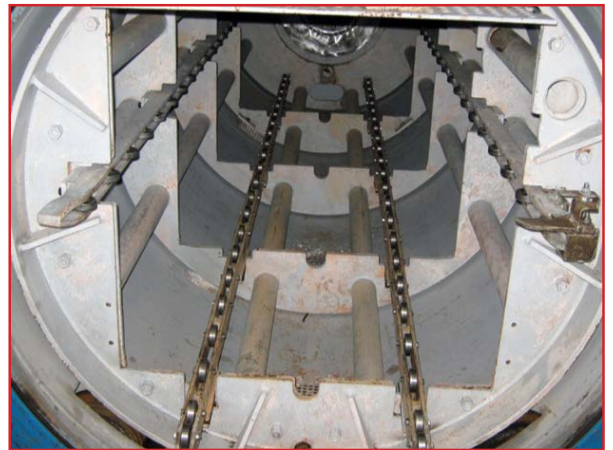
AFTER

Upon inspection, these vessels looked even better than the first cooker as evidenced by a black-gray passivated metal surface. No deposit was visible throughout the cookers. Plant personnel were grateful and the results were "much better than expected." Subsequently, the plant was started up and the product appearance was superb.
