# Gulf Coast Chemical Plant Minimizes Costly Exchanger Cleaning Costs with FlexPro®

*Cooling Water Innovation and Technology*

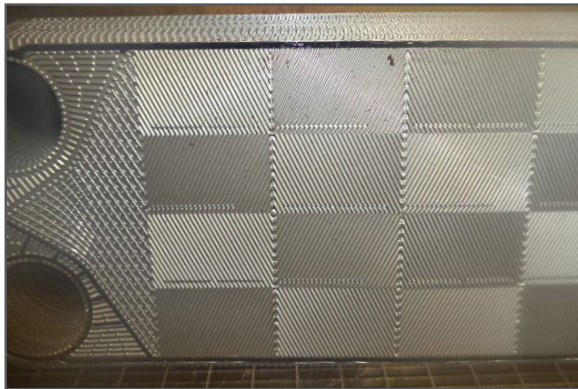
*Plate and Frame Heat Exchanger Cooling Water Side with FlexPro® Treatment*

Since switching to FlexPro®, the plant systems have not experienced any fouling or deposition, and corrosion control has remained very good. The hot, low-flow plate and frame exchangers exhibited no deposition during a planned outage following two years of operation with FlexPro®. The new process unit heat exchangers also exhibited no deposition during a planned outage following two years of FlexPro® use.

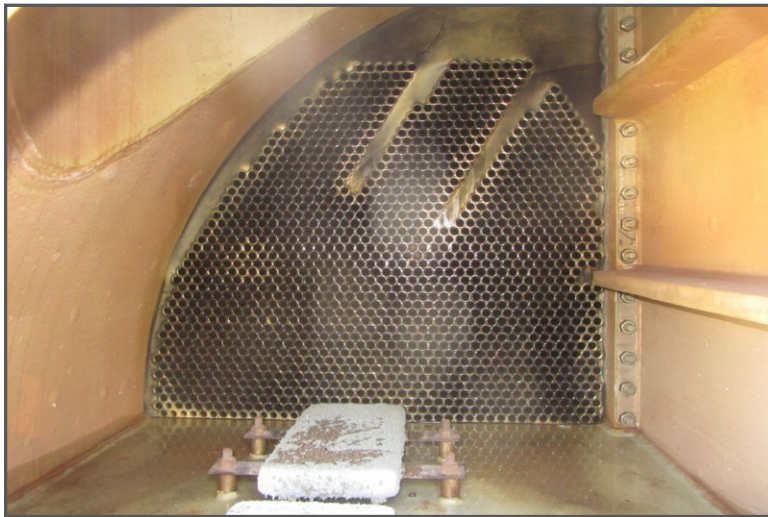
*New Process Unit Heat Exchanger Cooling Water Side with FlexPro® Treatment*

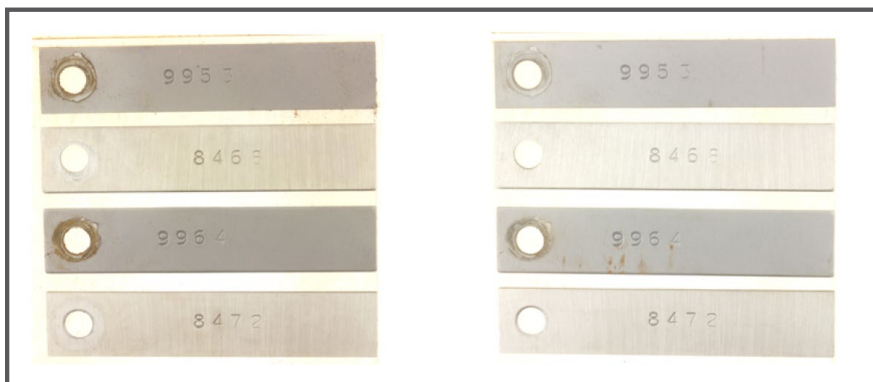
*Before and after cleaning photos of mild steel and stainless steel corrosion coupons, FlexPro® Treatment*
